HEMLOCK VALLEY SNOW AVALANCHE HAZARD ASSESSMENT

FINAL

Prepared for: Fraser Valley Regional District 45950 Cheam Ave. Chilliwack, BC V2P 1N6

6 October, 2020

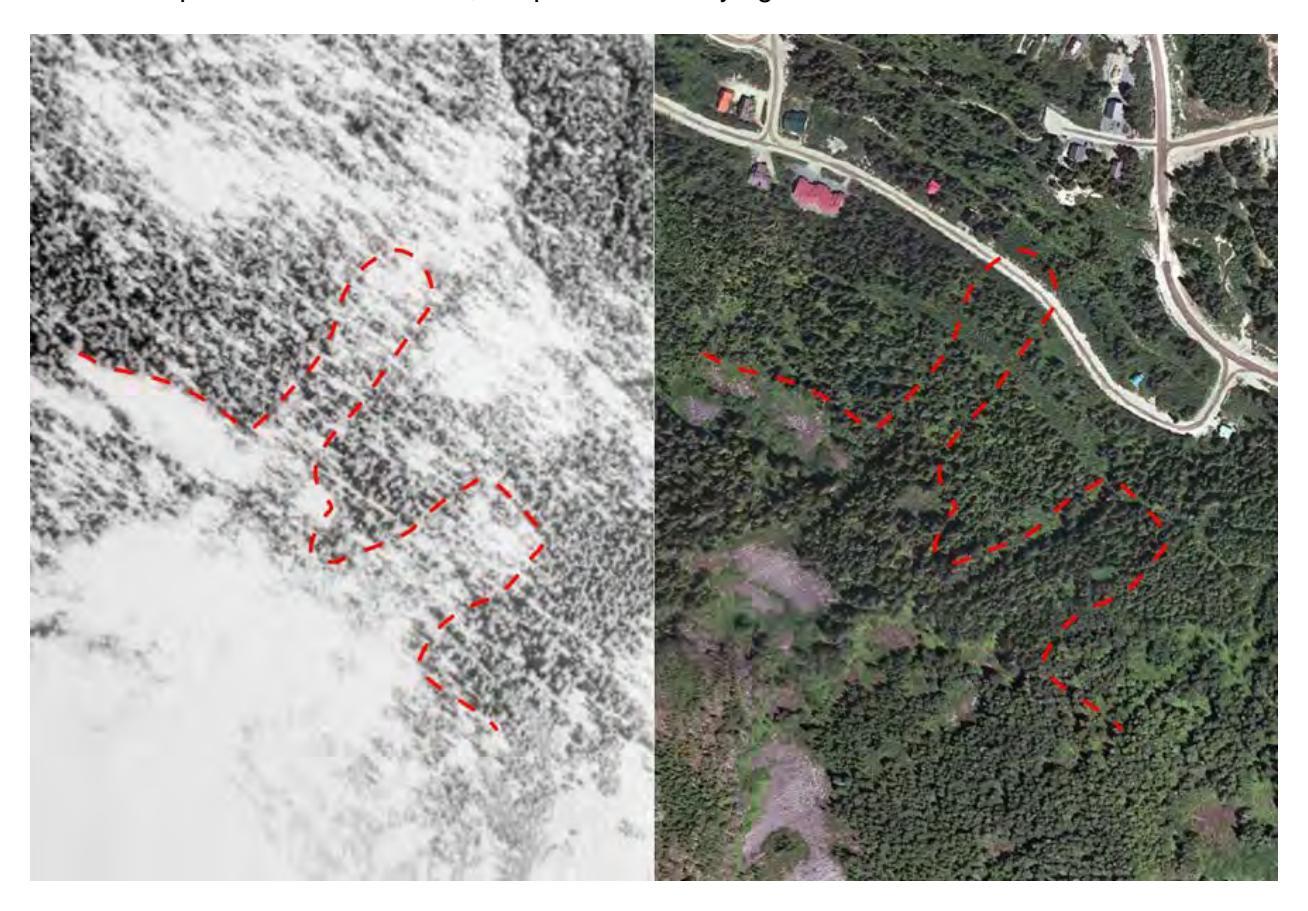
The photographs showed trim lines (location of vegetative type and age differences) of preceding snow avalanche events that occurred at least once between the years the air photos were taken. Prominent avalanche related trim lines were observed in the 1930 and 1951 air photos, as they were both taken prior to logging. Trim lines were observed close to Edelweiss Drive in two areas (Figure 2), suggesting large avalanches reached near the road pre-1930. These same trim lines were not apparent in the 2016 photograph, which suggests that avalanche events similar to the pre-1930 events have not occurred since then.

Figure 2. Comparison of aerial photographs from 1930 (left) and 2016 (right) for the Edelweiss Drive area. Red dashed line indicates the approximate location of trim lines observed in 1930 photograph.

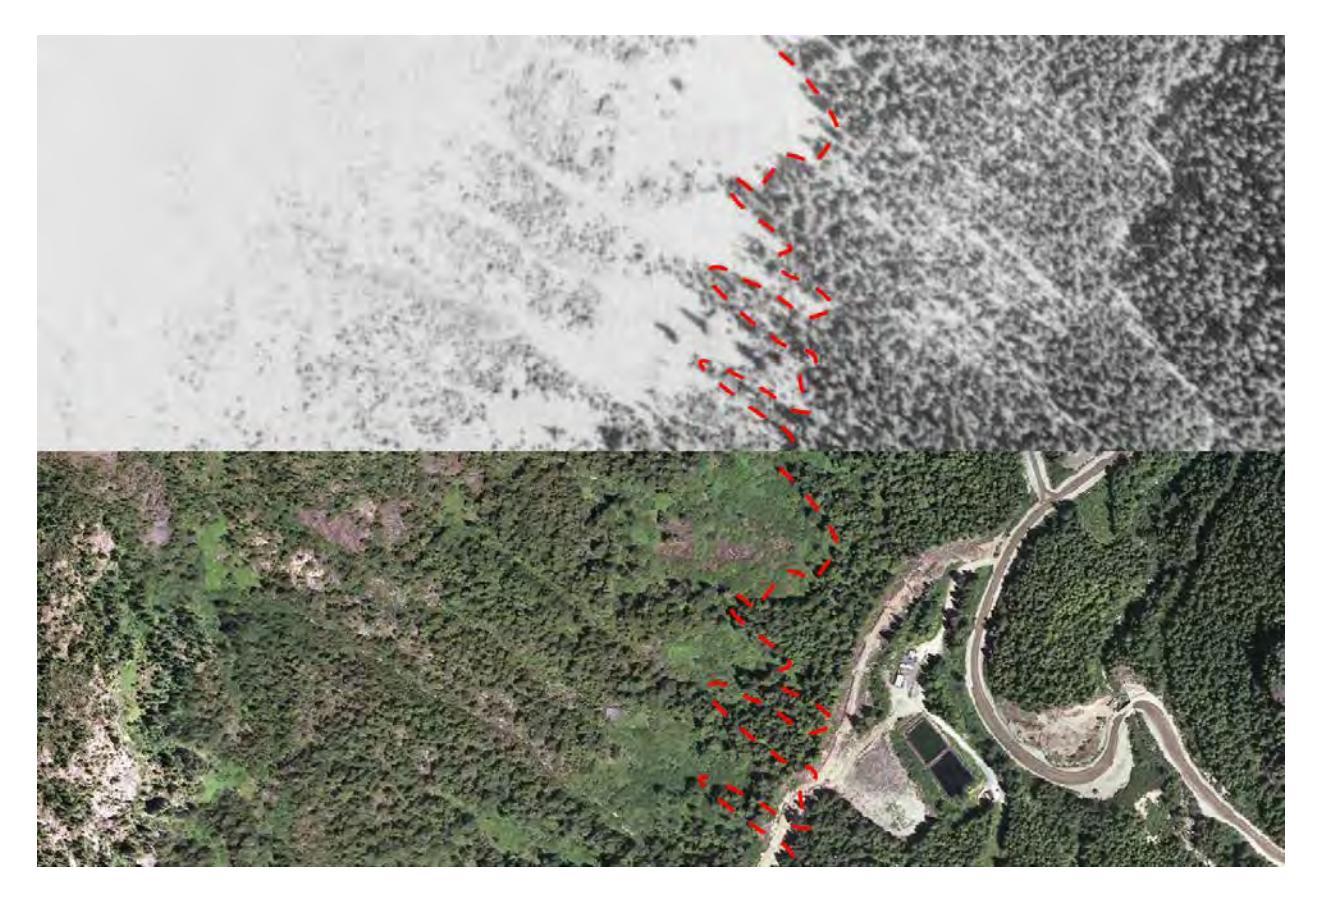
forest growth since logging in 1960's were generally similar to pre-logging conditions near the sewage lagoons area (Figure 3), although some areas could not be compared due to road and infrastructure construction since the logging activities. There was no obvious trim line in the 2003 air photo of the reported avalanche that reached the fence of the sewage lagoons in 1999 by D&E McClung Enterprises Ltd. (2010), suggesting that the avalanche debris flowed through the trees without knocking them down. This is not uncommon for a wet flow, which still has destructive potential for structures, despite not destroying the forest.

Figure 3. Comparison of aerial photographs from 1930 (top) and 2016 (bottom) for the sewage lagoons area. Red dashed line indicates the approximate location of trim lines observed in 1930 photograph.

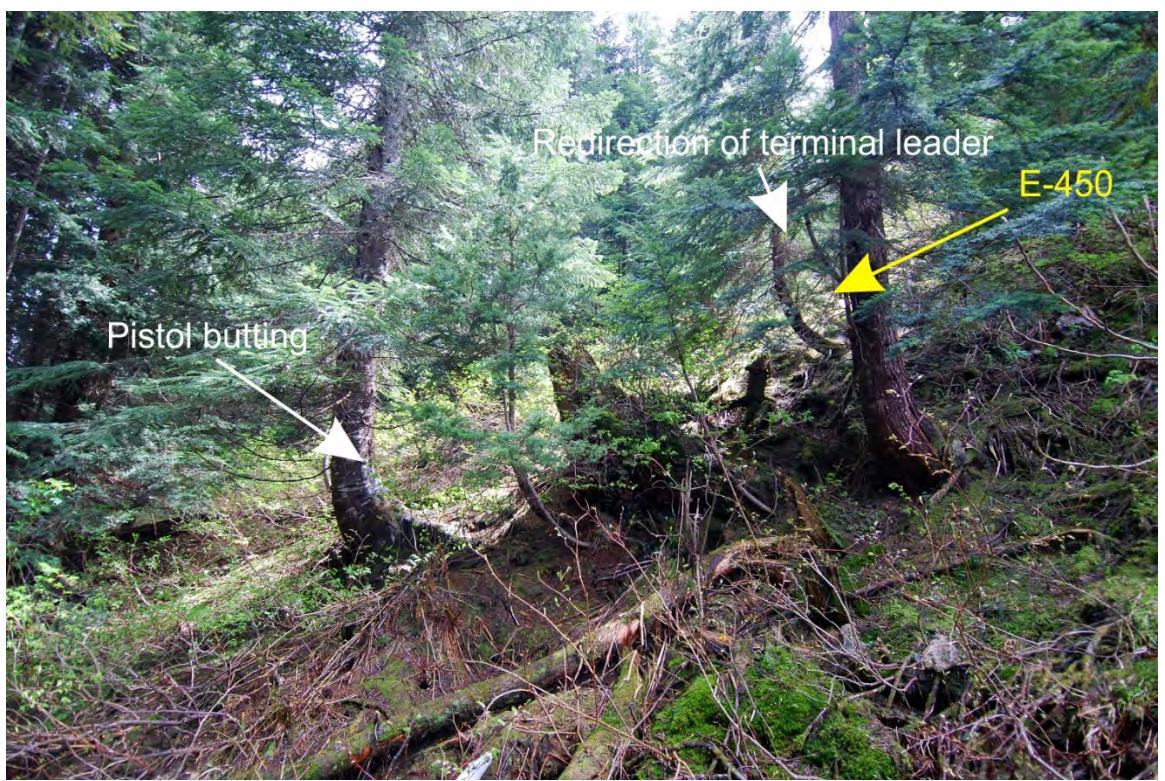
Photograph 6. Looking southeast towards vegetation damage about 90 m upslope of Edelweiss Drive within path E-450.

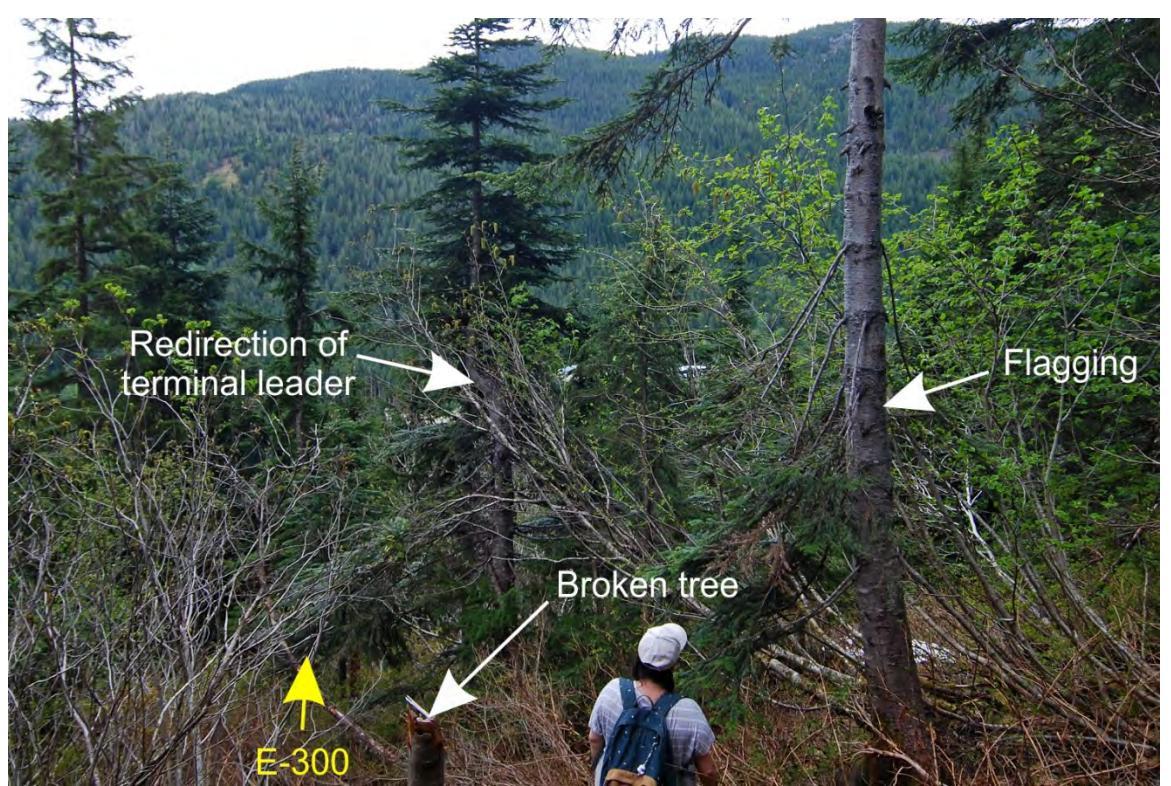
Photograph 9. Looking northeast and downslope along path E-300 towards vegetation damage in the track of the path.

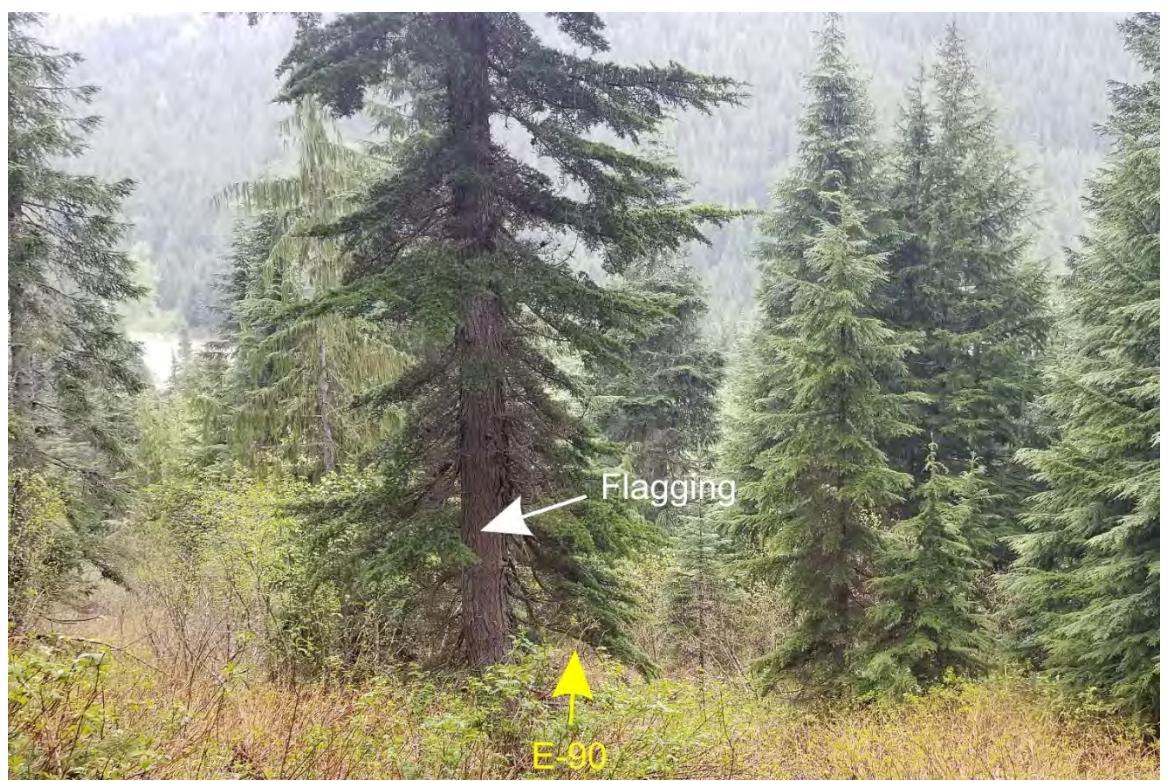
Photograph 11. Looking northeast and downslope along path E-90, looking towards vegetative clearing and damage of vegetation within the track.

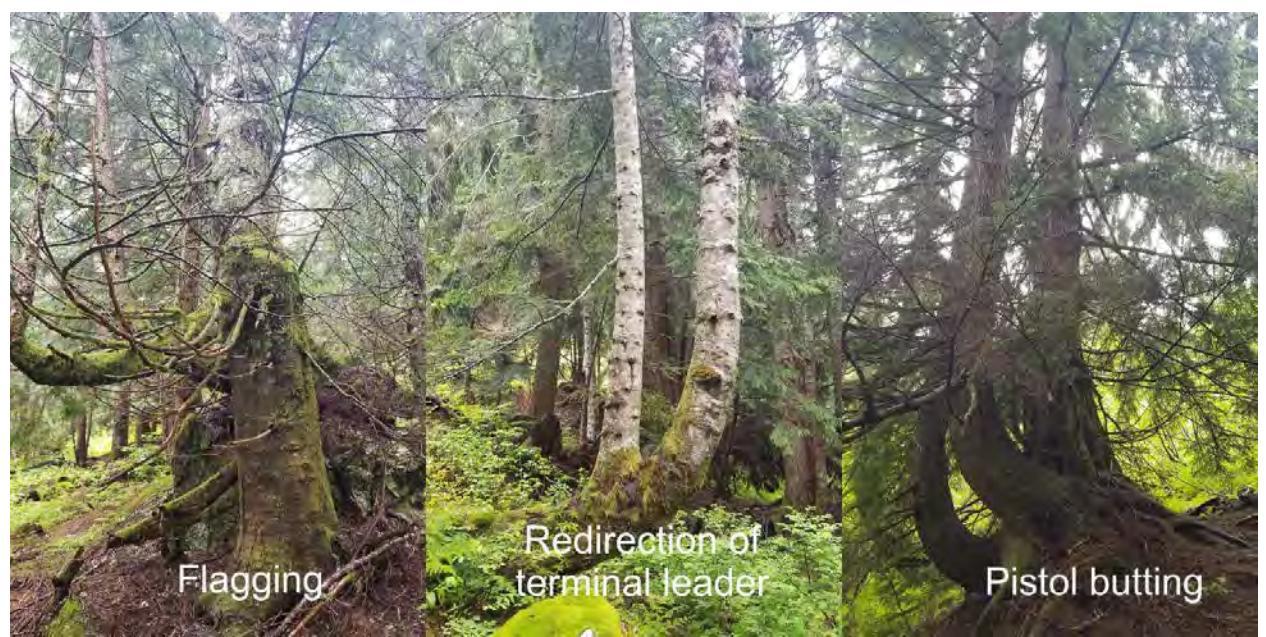
Photograph 14. Examples of vegetation damage within the runout zones of paths SL-105 and SL-200.
