Fraser Valley Regional District

Hazard Report

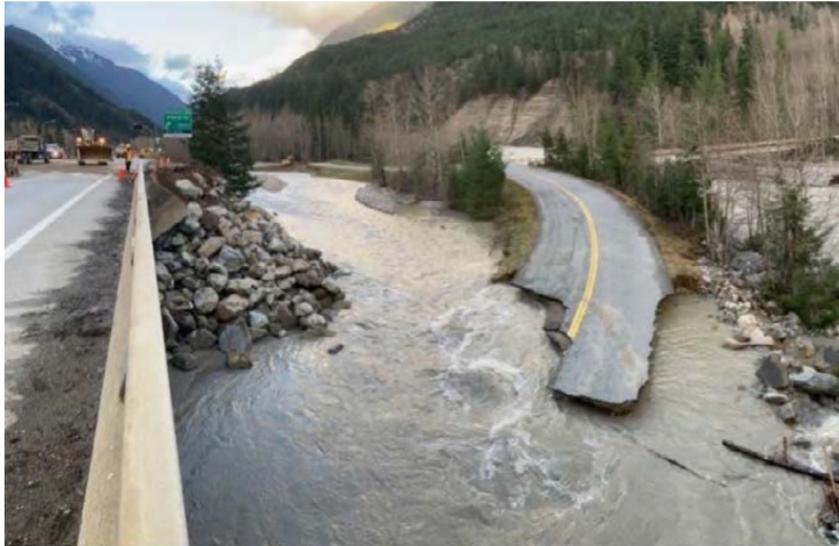
Figure 2-1.

Damage associated with the Coquihalla River flooding its right bank near the Othello Interchange on Highway 5 in November 2021 (BC Ministry of Transportation, 2021).

Clear-water floods can be destructive to communities. Damage to roads, utilities, and critical facilities (e.g. Figure 2-1) incurs economic costs and risks to health and safety of those that have limited access to essential resources. Residential and commercial damage caused by flowing and standing water can translate to loss of life, income, and assets. Bank erosion associated with floods can undermine roads and building foundations. Environmental concerns include disruption to aquatic ecosystems and loss of habitat (Talbot et al., 2018).

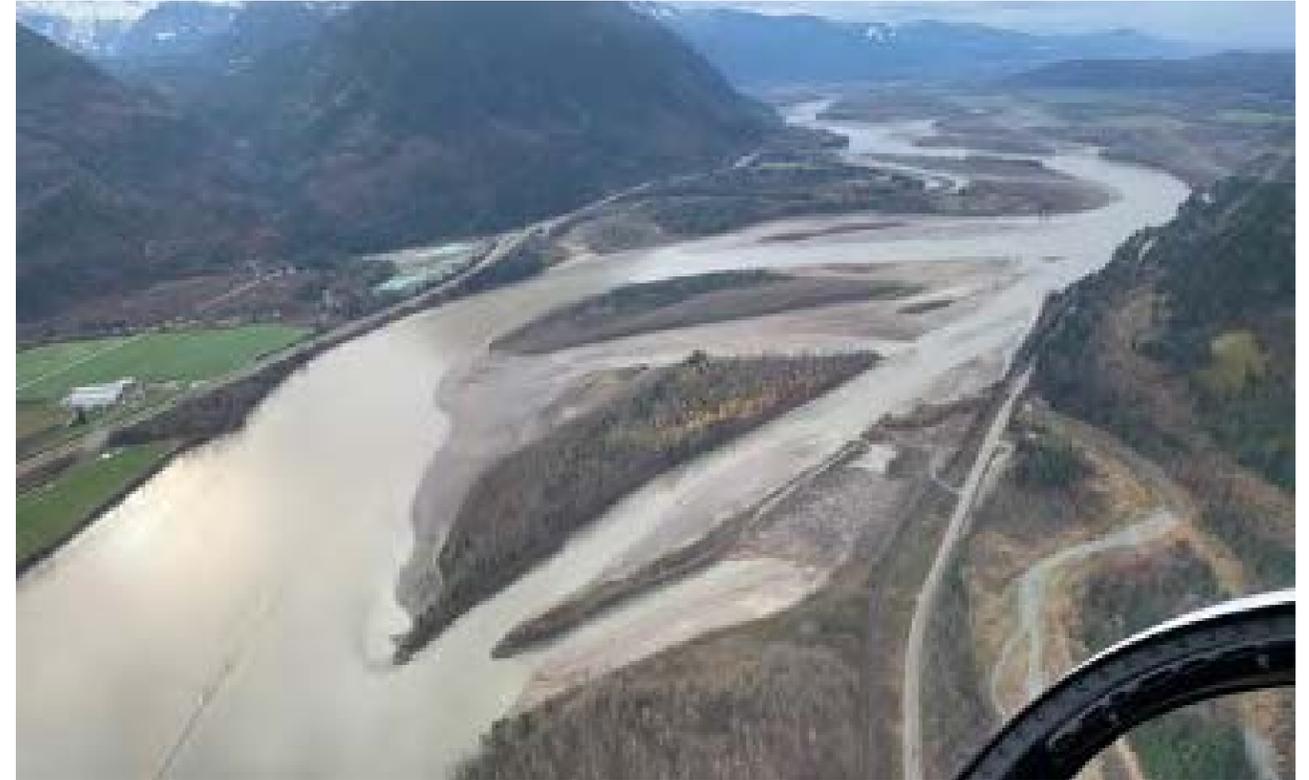
Figure 2-2.

Aerial view of the Fraser River valley looking east along Highways 1 and 7 in Electoral Area B during the November 2021 flood event in southern B.C. Photo: BGC, 2021.

The atmospheric river in southern B.C. in November 2021 caused widespread flooding in the FVRD, including of the Sumas Prairie (Figure 2-2). A state of local emergency was declared in response to the risk to life and property.

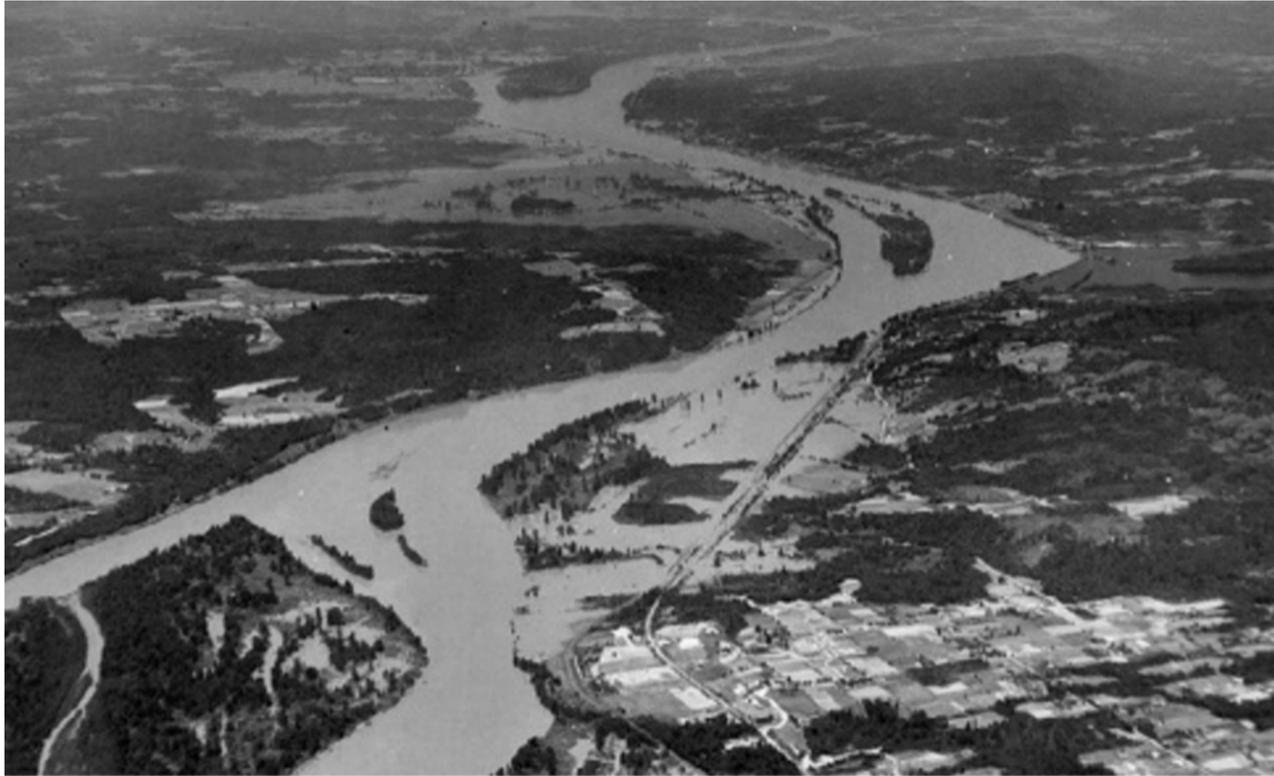
Figure 2-3.
Aerial view of Mission to Barnston Island during the Fraser River flood in 1948 (Chilliwack Museum and Archives).

Three prior major floods have been recorded on the Fraser River in the Lower Mainland, in 1894, 1948, and 1972 (Government of Canada, 2010). The 1948 flood resulted from a heavy snowpack and record warm temperatures. It inundated nearly one-third of the Fraser Valley, severed both transcontinental rail lines, and cost an estimated \$20 million (\$147 million in 1998 dollars) (Government of Canada, 2010; Figure 2-3).

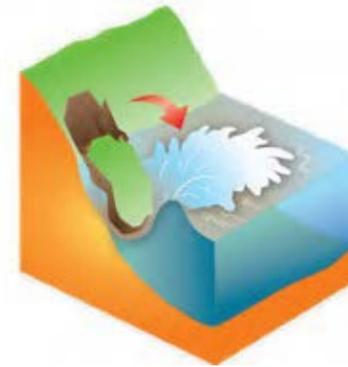
Figure 2-7.

Landslide-generated tsunami schematic (University of Hawaii, (n.d.)).

Landslides that deposit into a waterbody can create landslide-generated waves (Figure 2-7). Landslide-generated waves can damage properties on the shoreline of the waterbody. In the FVRD, the 2007 Chehalis Lake tsunami transported silt to boulder-sized sediment that modified the lake shoreline (Roberts, McKillop, Lawrence, Psutka, Clague, Brideau, Ward, 2013).

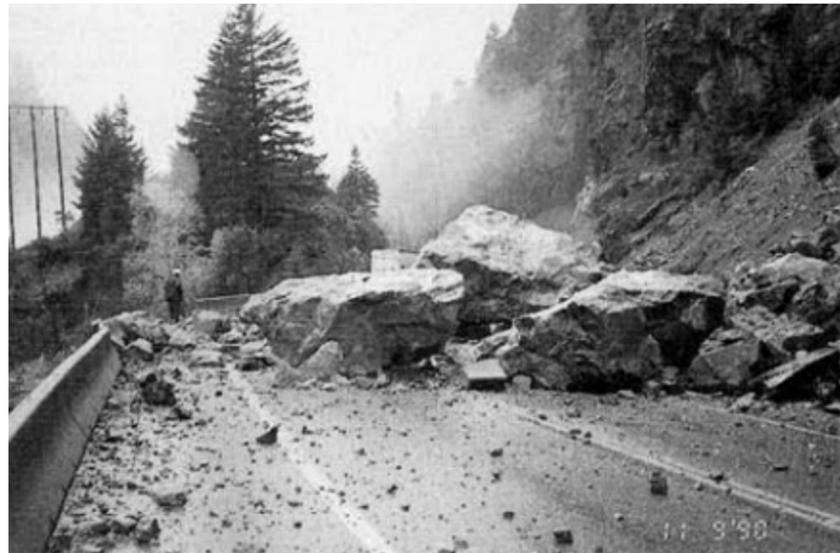
Figure 2-8.

Rock fall on Highway 1 near Yale (Evans & Savigny, 1994).

Throughout the FVRD, there is a long history of landslides ranging from relatively small rock falls to the 47 million m³ 1965 Hope Slide. Rock falls are common in the steep, mountainous terrain of the FVRD, and are most reported along highway corridors that follow the steep valleys of the major river systems (Figure 2-8). Rock falls are more frequent in spring (snowmelt) and fall (heavy rainfall), with some attributed to freeze-thaw cycles and frost wedging in winter (Piteau & Peckover, 1978).

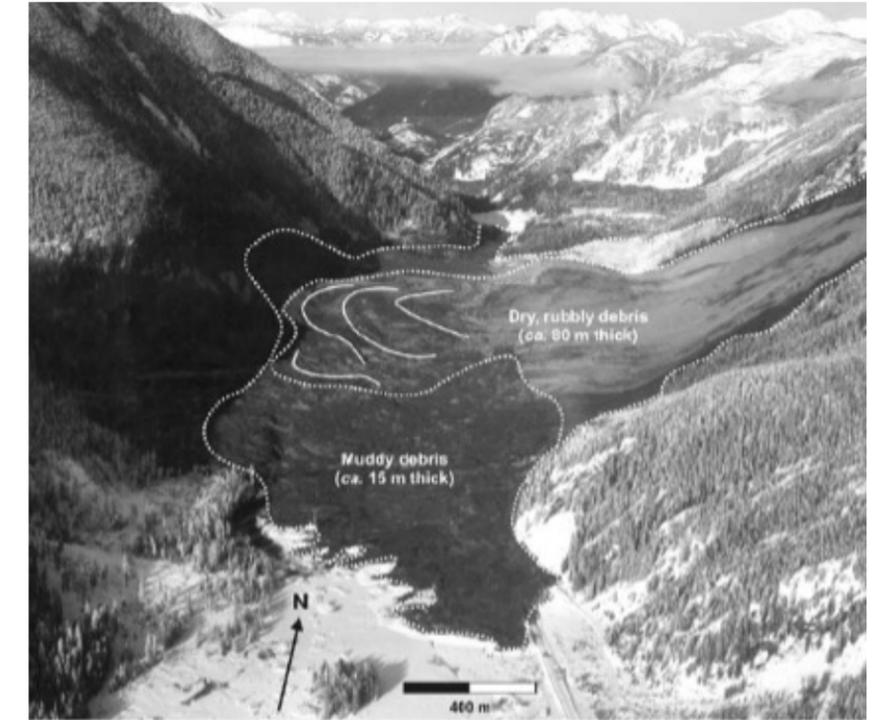
Figure 2-9.

Photo of the Hope Slide after event (Orwin, Clague, & Gerath, 2004). Sunshine Valley is 3 km south of this location.

The 1965 Hope Slide in the Sunshine Valley (Figure 2-9) is one of the largest recorded rock avalanches in Canada. It occurred in two phases three hours apart and inundated several kilometres in the corridor with debris. After the failure, it was observed that multiple discontinuities dipped toward the valley (Evans & Savigny, 1994).

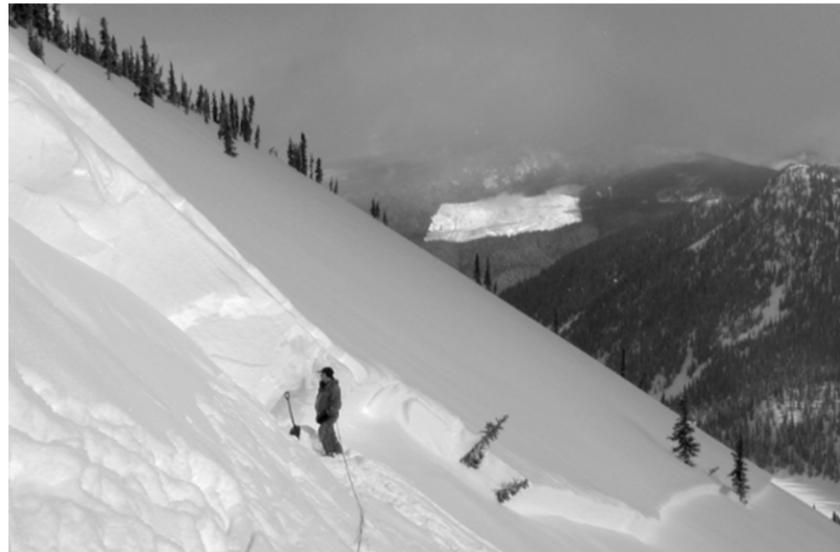
Figure 2-11.

Crown of slab avalanche (Jamieson, 2006).

Slab avalanches involve a cohesive slab of snow sliding along an underlying weak snowpack. These avalanches have a distinct, broad fracture line along their crown (Dynamic, 2020). Freeze/thaw cycles create a layer of distinct particle shapes of larger size that do not bond well with overlying snowfall. Larger grains create weaker bonds, as pore spaces dictate fewer bonds per unit area. This weaker crust cannot withstand shear forces perpetuated by accumulated snowfall, and failure occurs (Jamieson, 2006).
